NASA Technical Memorandum 102681
USAAVSCOM Technical Report 90-B-003

Behavior of Composite/Metal Aircraft Structural Elements and Components Under Crash Type Loads--What Are They Telling Us?

May 1990

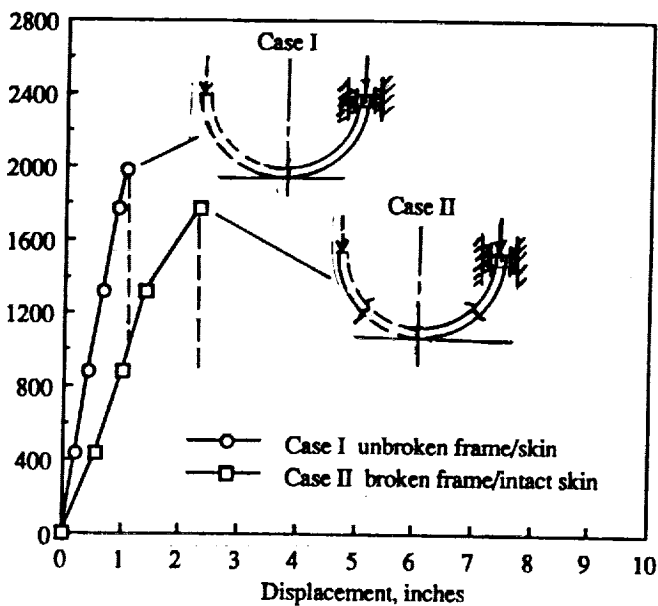
(a) Load-displacement.

Static analytical studies.- To demonstrate analytically the apparent behavior of the frames under load (exclusive of the local buckling which actually initiated the failure in the static case), two DYCAST finite-element models were constructed. For ease of analysis, a typical I-section was modeled from the specimens described in the "Single Frame Studies" section. The frame was loaded at the top and a simulated ground plane (ground contact springs) resisted the vertical movement of the frame during load application. Only half the frame was modeled using thirty-four (34) I-section beam elements with boundary conditions imposed at the bottom node of the model to account for the symmetrical situation. The top node was constrained to allow only vertical displacement thus simulating the effect of a very stiff floor across the frame diameter. The static load was slowly increased until an input failure strain for the material (0.0086) was exceeded at the point of loading and failure was indicated. The curve labeled *unbroken frame, case I*, in figure 12(a) is the load-deflection plot for this case I.

A second DYCAST model, *broken frame, case II*, was also run wherein the bottom point of the frame was modeled with two short skin segments to represent the different boundary condition following the initial failure of the frame. This condition will be discussed further relative to the composite subfloor test with the skinned subfloor specimen. The curve in figure 12(a) labeled *case II* is the load-deflection response for this frame loading case. Essentially, the frame load increases along the *case I* curve to the point of initial failure at the bottom of the frame. After the frame fractures the boundary changes to one considerably weakened--down to the bending stiffness of the skin alone at that location. The load then drops to the lower curve, *case II*, which represents the stiffness of the section with the weakened boundary on the bottom end of the frame. The load continues to increase along the *case II* curve until secondary failures at some other location on the frame circumference occur.

Furthermore, a comparison of the analytical cases (figure 12(a)) with the actual static load-deflection of the Z-section (figure 11(b)) indicates very similar load-deflection behavior patterns as discussed above. Although the Z-frame had no skin, if the ends jam together (as they did in several cases), the boundary is effectively between the skin stiffened case and a guided boundary. Thus, the predicted maximum moment location in the simple beam-frame model at about 50 degrees (See figure 12(b)) agrees well with the 54 and 58 degree failure locations in the experiment with the Z-section frame.

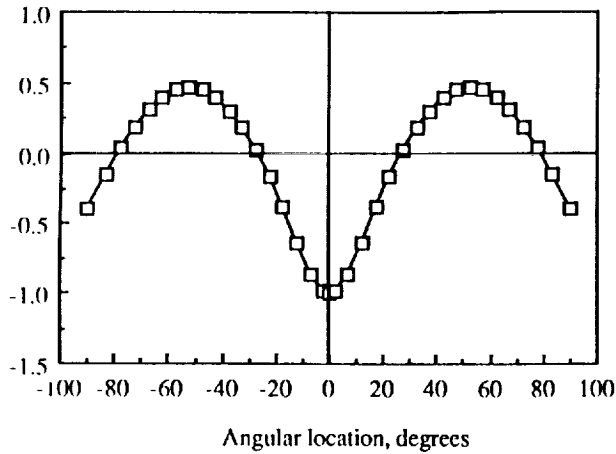
(b) Case I---Normalized moment (Prior to failure).

An examination of the normalized distribution of the bending moment on the frame shown in figure 12(b) provides insight and a better understanding of the failure/behavior. Maximum moments are indicated (just prior to failure) to be at the 0 degree location and between $\pm 50-60$ degrees from the bottom contact area. The locations correlate well with the failure locations in the experiment with the Z-frame.

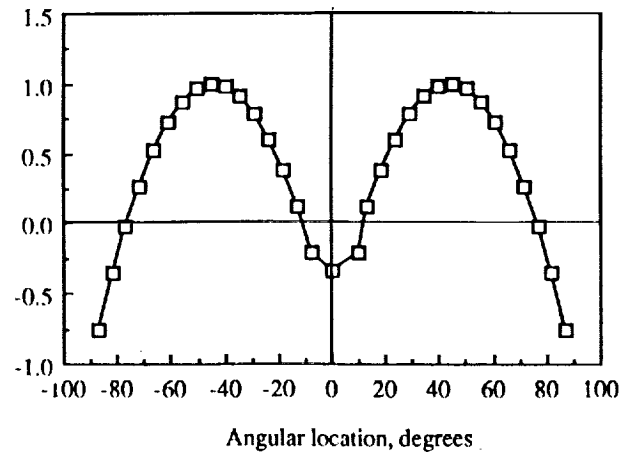
(c) Case II---Normalized moment (Broken frame-intact skin).

Normalized bending moment distribution on the broken frame is presented in Figure 12(c). As may be noted, the distribution is quite similar to the initial model results in figure 12(b). The failure location is at the maximum bending moment location predicted to be about ± 45 degrees which is somewhat lower than the same location shown in the initial model of the unbroken frame. The agreement between the predicted behavior by the two models, however, is still considered good. The effect of diameter on the moment distribution of the frame was assessed with a model having a 75 inch diameter (twice the initial diameter). The distribution was identical to the smaller diameter results, however, the loads producing the moments differed between the two models (as expected). Moment in terms of geometry and load for a point loaded ring²⁸ shows that the maximum moment will occur at the same angle for different values of diameter.

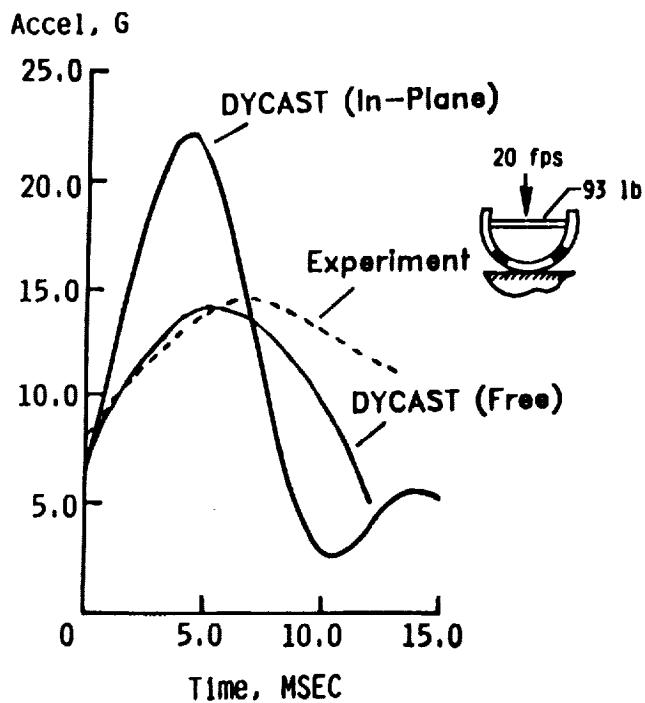
(c) Experimental and analytical accelerations.

Dynamics analytical studies. Experimental and analytical model results for the composite Z-frame subjected to a 20 ft/s impact are shown in Figure 13(c). The first 15 milliseconds of the experimental acceleration of the floor and analytical predictions are shown. In one analysis, in-plane deformations were constrained to the plane of the frame whereas in the other, the frame was free to twist and bend out-of-plane. As noted in the figure, agreement between the "free" model and the experiment is good for the initial peak load. Later the agreement is less because the backstop and clear fence in the experiment, which was not modeled, began to provide support to the twisting and bending frame. The in-plane model results are about 60% higher when compared to the experiment and the free model results. Such results emphasize the importance of knowing and modeling the experimental boundary conditions to understand the dynamic and static behavior of structures under crash loadings. Unfortunately, mixed boundary conditions often exist or occur in the experiments.

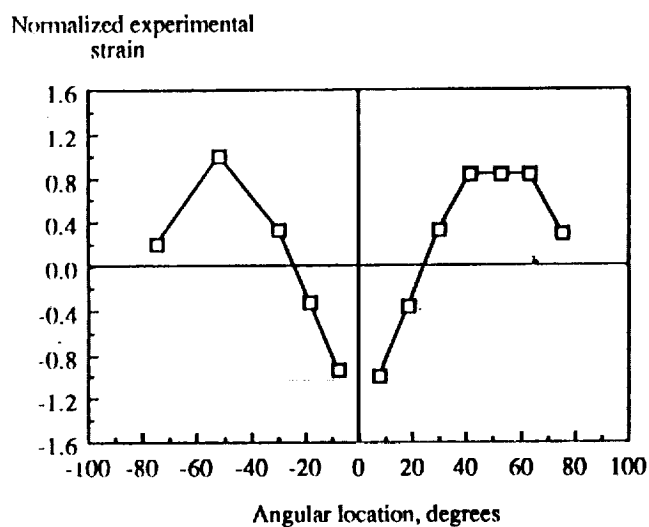
(c) Normalized circumferential strain distribution.

Dynamic tests. A photograph of a skeleton subfloor after an impact test onto a concrete surface at 20 feet per second is shown in Figure 15. In the dynamic test of the skeleton subfloor, fractures were produced at notches in the frames (Figure 15(a)). The locations, shown in figure 15(b), were also near the point of impact (about 11 degrees because of the splice plate) and at three other locations up the circumference of the frames (55 degrees and 78 degrees) totalling 15 fractures for all three frames. The impact energy exceeded the energy absorbed by the local fractures and the floor bottomed out during the impact. The normalized circumferential strain distribution measured on the flange of the front frame during the dynamic test just before first failure is shown in Figure 15(c). A comparison of the measured distribution to the predicted moment distribution of Figure 12(b) and (c) shows essentially identical shape between the single frame and skeleton frame distributions. Maximum values at 0 degrees and at approximately 50 to 55 degrees for the experiment agree well with the analytically predicted locations on the frame.

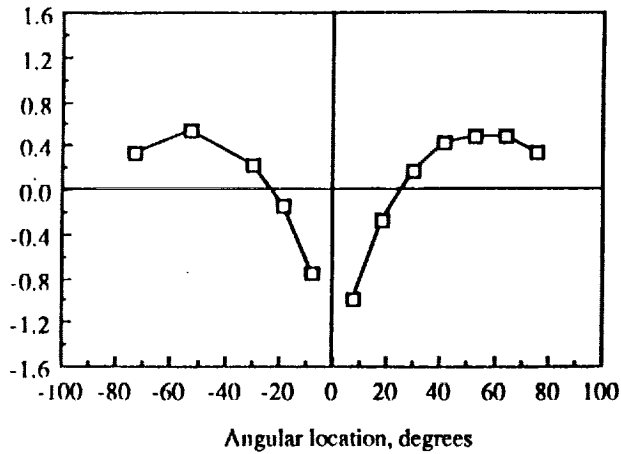
(c) Normalized circumferential strain distribution.

Impact results for the subfloor with skin after an impact of 20 feet per second are shown in Figure 16. A photograph of the subfloor specimen after the test is shown in Figure 16(a). Points of failure of the frames in this specimen are indicated in figure 16(b). Again the points of failure are at or near the impact point (within 12 degrees) and circumferentially at about 56 degrees up both sides of the frame on the middle and back frame and 45, 12 and 22.5 degrees on the front frame. It was observed that the subfloor impacted first on the front area which possibly explains the 12 and 22.5 degree fractures being different from the other locations. Again all three frames were involved in the failures. Some delamination of the frames from the skin was evident but the skin remained intact. Normalized strain distribution (just prior to first failure) measured on the skin at the location of the front frame during the dynamic test showed essentially identical shape as the single frame and skeleton frame distributions. As was the case for the skeleton subfloor maximums at 0 degrees and at approximately 50 to 55 degrees for the experiment agree well with the analytically predicted locations on the frame.

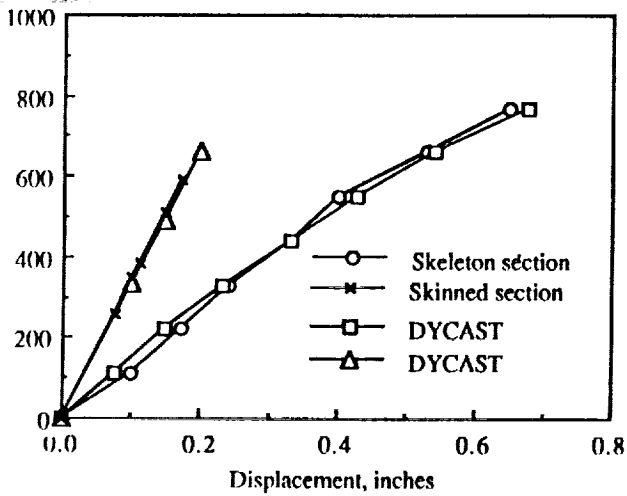
Figure 17. - Comparison of experimental and analytical stiffness of composite skeleton and skinned subfloors.

Analytical studies. The contribution of the skin to the stiffness of the section with the nonsymmetrical frames is illustrated in figure 17. Static load-deflection data for the unskinned subfloor and the skinned subfloor along with the DYCAST predictions are shown in the figure. It can be noted that the subfloor stiffness (with skin) is approximately three times the stiffness of the skeleton subfloor, thus the skin's contribution to the structure is to maintain in-plane deflections of the non-symmetrical Z-section and prevent any substantial twisting of the frames. Out-of-plane bending and twist were allowed in the skeleton subfloor predictions.
